MARK-V GROUND FAULT RECTIFICATION CASE STUDY

Adeel Imtiaz
FFC, Pakistan

INTRODUCTION

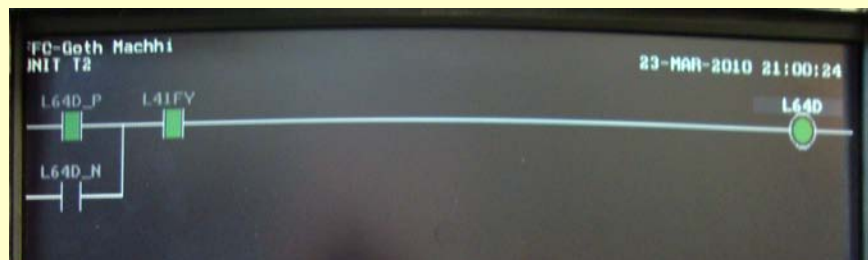
L64D Energized

In above picture it is clear that 125VDC positive terminal ground contact L64D_P was energized actuating L64D ground detector soft relay.

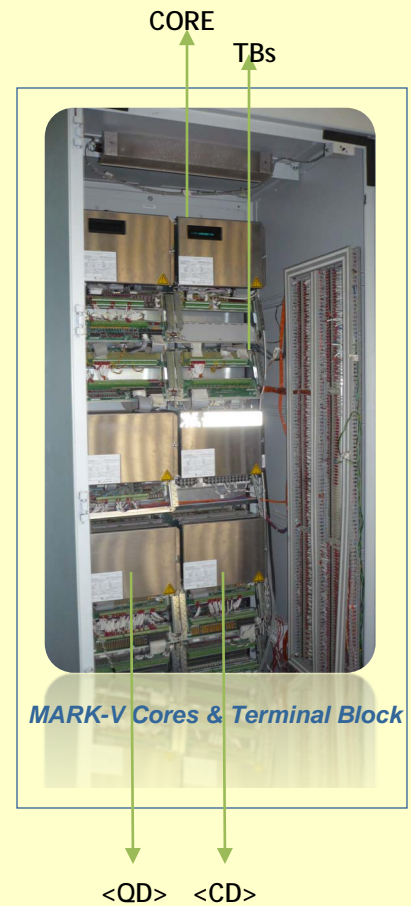
125VDC Power Cables to TBs

The goal of this procedure was to disconnect all TBs and cores from power distribution core one by one till L64D reset.

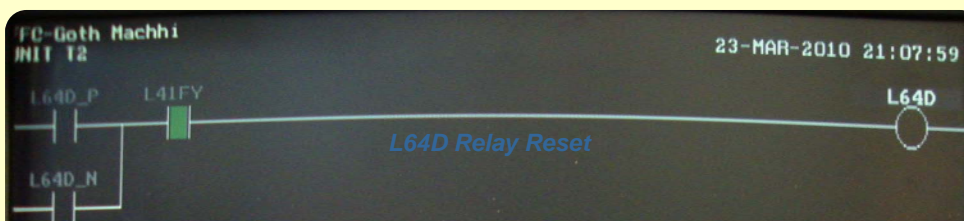
- The procedure started by disconnecting 125VDC power cables to terminal block DTBA of <QD> core. Two multi-meters were also placed to measure supply against ground. L64D did not reset.
- In the next step power cable of terminal block DTBB of <QD> was removed but L64D did not reset.
- In this way all the digital inputs of <QD> core were isolated. Digital inputs on <CD> core were to be disconnected in the next phase.
- The L64D relay was reset when power cable was disconnected from terminal block DTBA of <CD> core.

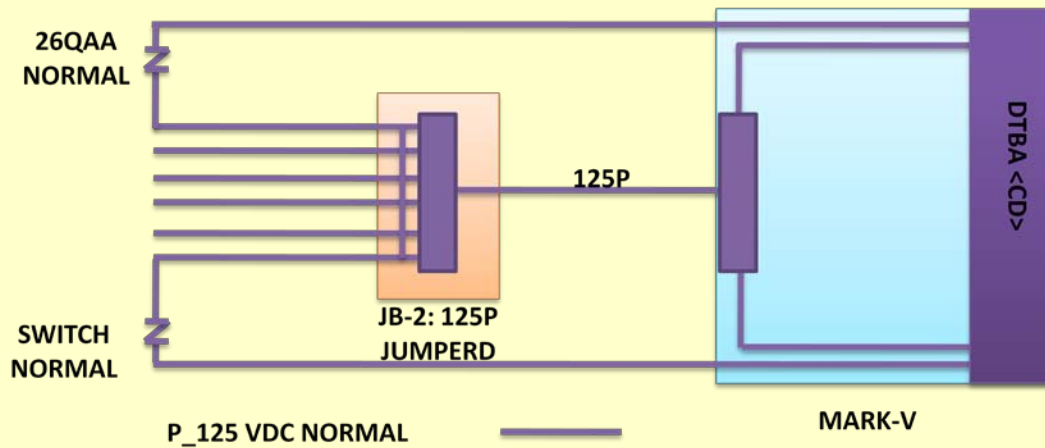
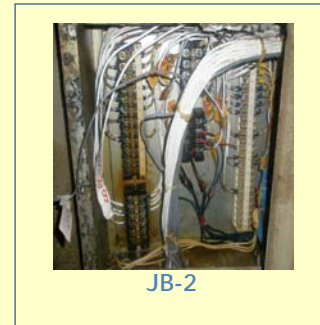
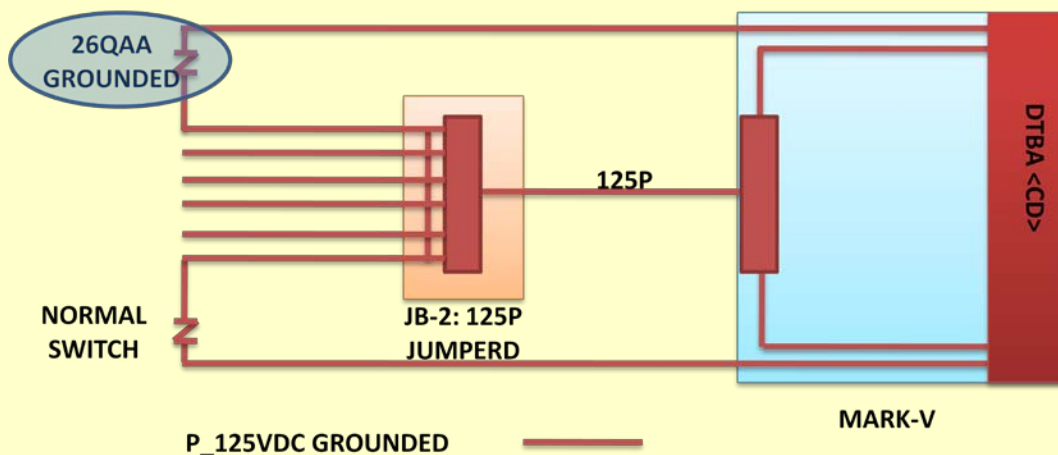
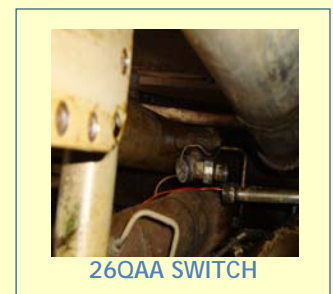
- DTBA contained 19 pairs of cables which were suspicious. Each pair was removed one by one to narrow down the fault. It revealed that out of 19 pair 14 pairs were grounded.
- On the basis of analysis it was concluded that positive grounded supply cable coming from field is looped in JB-2 from where ground fault is spread to every field device looped from JB-2 terminal block as shown in the picture. The figure shows that a single grounded sensor 26QAA caused ground fault in all loops due to cable looping at JB-2.

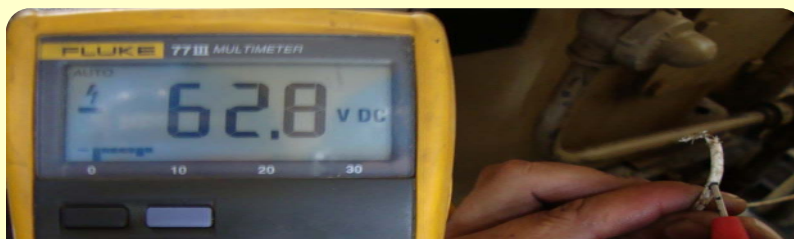
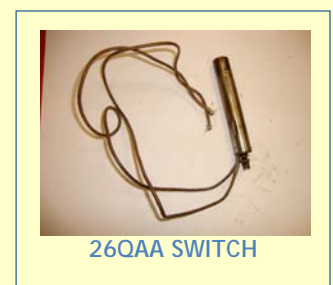
- To identify the root cause cables were disconnected from JB-2: TB-A. As soon as the cable from grounded switch 26QAA atomizing air high temperature was disconnected L64D reset, "125VDC Battery Ground" alarm disappeared while "Atomizing air high temperature" alarm initiated.
- On field inspection 125VDC supply cable was found damaged and switch was in bad conditions. Voltages were sinking to ground from both cable and switch. Cable was repaired and protected. Switch power terminal to ground resistance was 2K Ω , far less than MARK-V ground threshold (33K Ω). Switch was bypassed.
