MARK-V GROUND FAULT RECTIFICATION CASE STUDY

Adeel Imtiaz
FFC, Pakistan

INTRODUCTION

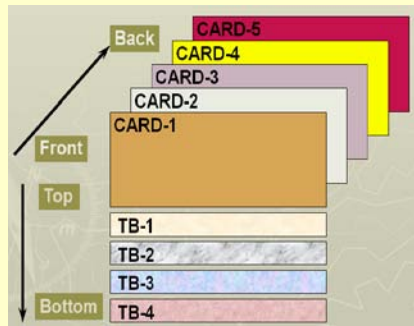
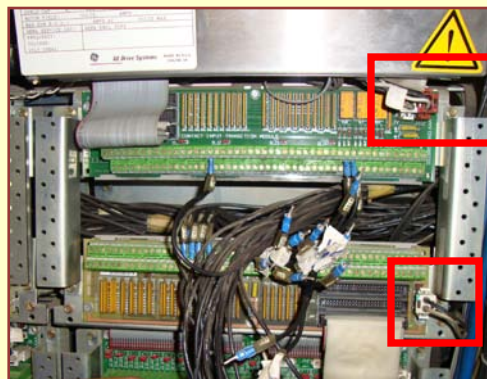
125VDC Power Cables to TBs

POWER CABLE

The goal of this procedure was to disconnect all TBs and cores from power distribution core one by one till L64D reset.
